# BELIZE ELECTRICITY LIMITED

April 23, 2020

## BEL Continues to Manage the Effects of Environmental Conditions on Power System

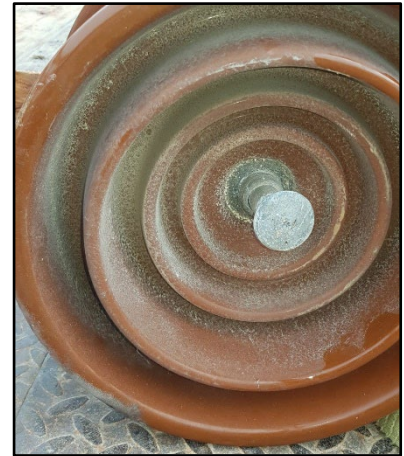
Belize Electricity Limited (BEL) teams continue to manage the effects of extended drought and seasonal dry weather conditions on our electric infrastructure, which have resulted in an increase of dust, smoke and soot contamination on power line equipment. Over the past few days, there has been an increase in pole fires due to excessive contaminants on insulators that cause them to fail, and bush fires that damage poles.

**Contamination on insulator**  
(above)

The ongoing weather conditions will continue to present challenges, and may potentially cause more outages. However, BEL assures customers that we continue to implement our intensified countrywide system maintenance program to mitigate these challenges. Our line teams are also working diligently in these challenging weather conditions while maintaining social distancing and using additional personal protective equipment in adherence to COVID-19 preventative measures.

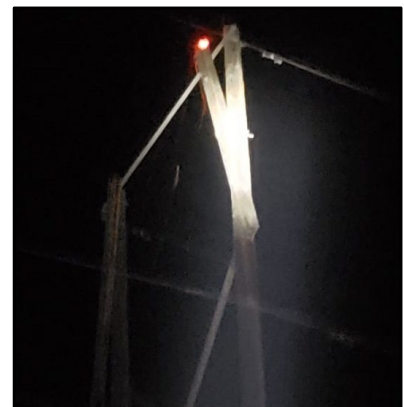
One such failure occurred early this morning on the 115kV transmission line that connects the national grid to the Mexican grid. At the time, the Mexican grid was supplying most of the energy being used in Belize, which resulted in a temporary system collapse. At 1:26 a.m. today, most of the country experienced a power outage due to a burnt crossarm on a transmission structure in the Orange Walk District. This was the result of excessive dust build-up on power line equipment, which caused an electrical fault on the structure.

**Burnt crossarm on transmission structure**  
(below)

Our teams responded immediately to isolate the system and commence repairs, then began sequenced restoration of power to most areas between 2:15 a.m. and 3:00 a.m. Power supply was restored to remaining areas of the Belize and Corozal Districts between 4:30 a.m. and 8:30 a.m.
